**PRELIMINARY SOILS REPORT ON 7.53 ACRE TRACT, BELVEDERE, S.C.**

**Investigation:** Excavation of numerous "holes" to determine make up of "fill" previously placed on area of tract adjacent to Highway US-25.

**Dates of Investigation:** June 26 and 27, 2006

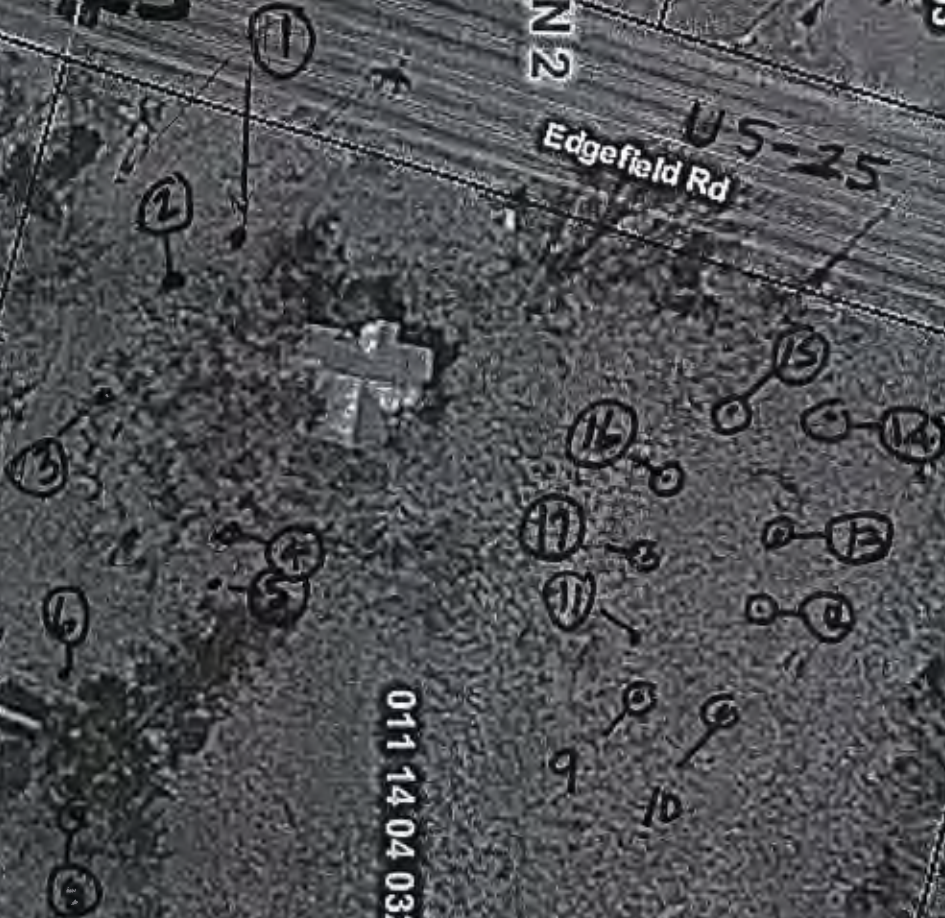
7.53 AC TRACT - LOCATION OF HOLES  
6/2006

**Investigation Approach:** Holes were dug in the pattern shown on the attached sketch. The locations were selected to identify the area and depth of the fill. In general, where possible, the depth of the hole was increased until the "original" soil was reached. The participants observed the digging of each hole and the material removed by the bucket at each stroke.

**Findings:** The material in each hole consisted of a mixture of various grades of "sand-clay" and various inorganic materials, principally asphalt and concrete. There were also some bricks and concrete blocks detected, although these were small in number. The asphalt was in pieces of 1-in to 6-inch in size and was well compacted. The concrete was mostly old sections of "curb and gutter" varying in length from 1-ft to 8-ft. One piece of concrete measuring approximately 6-ft by 5-ft by 8-in was located. The material removed from the holes was at least 90% soil with the remainder the inorganic materials noted above. In holes No. 9 through No. 17 the holes were dug to depths exceeding 8 feet without reaching the original soil.

In hole No. 12, sections of about 3 creosote cross ties were located. In hole, No. 10, a large piece of timber about 14-in by 14-inch by 6-ft was located. These were the only organic materials detected.

In all of the holes, the material was well compacted and no voids were detected. No evidence was seen of organic materials such as trees, stumps, garbage, plastic or refuse. No water was detected.
