# **BURNS COOLEY DENNIS, INC.**

Project No. 170287

### **Soils Data Report Truck Parking Facility Richland, Mississippi**

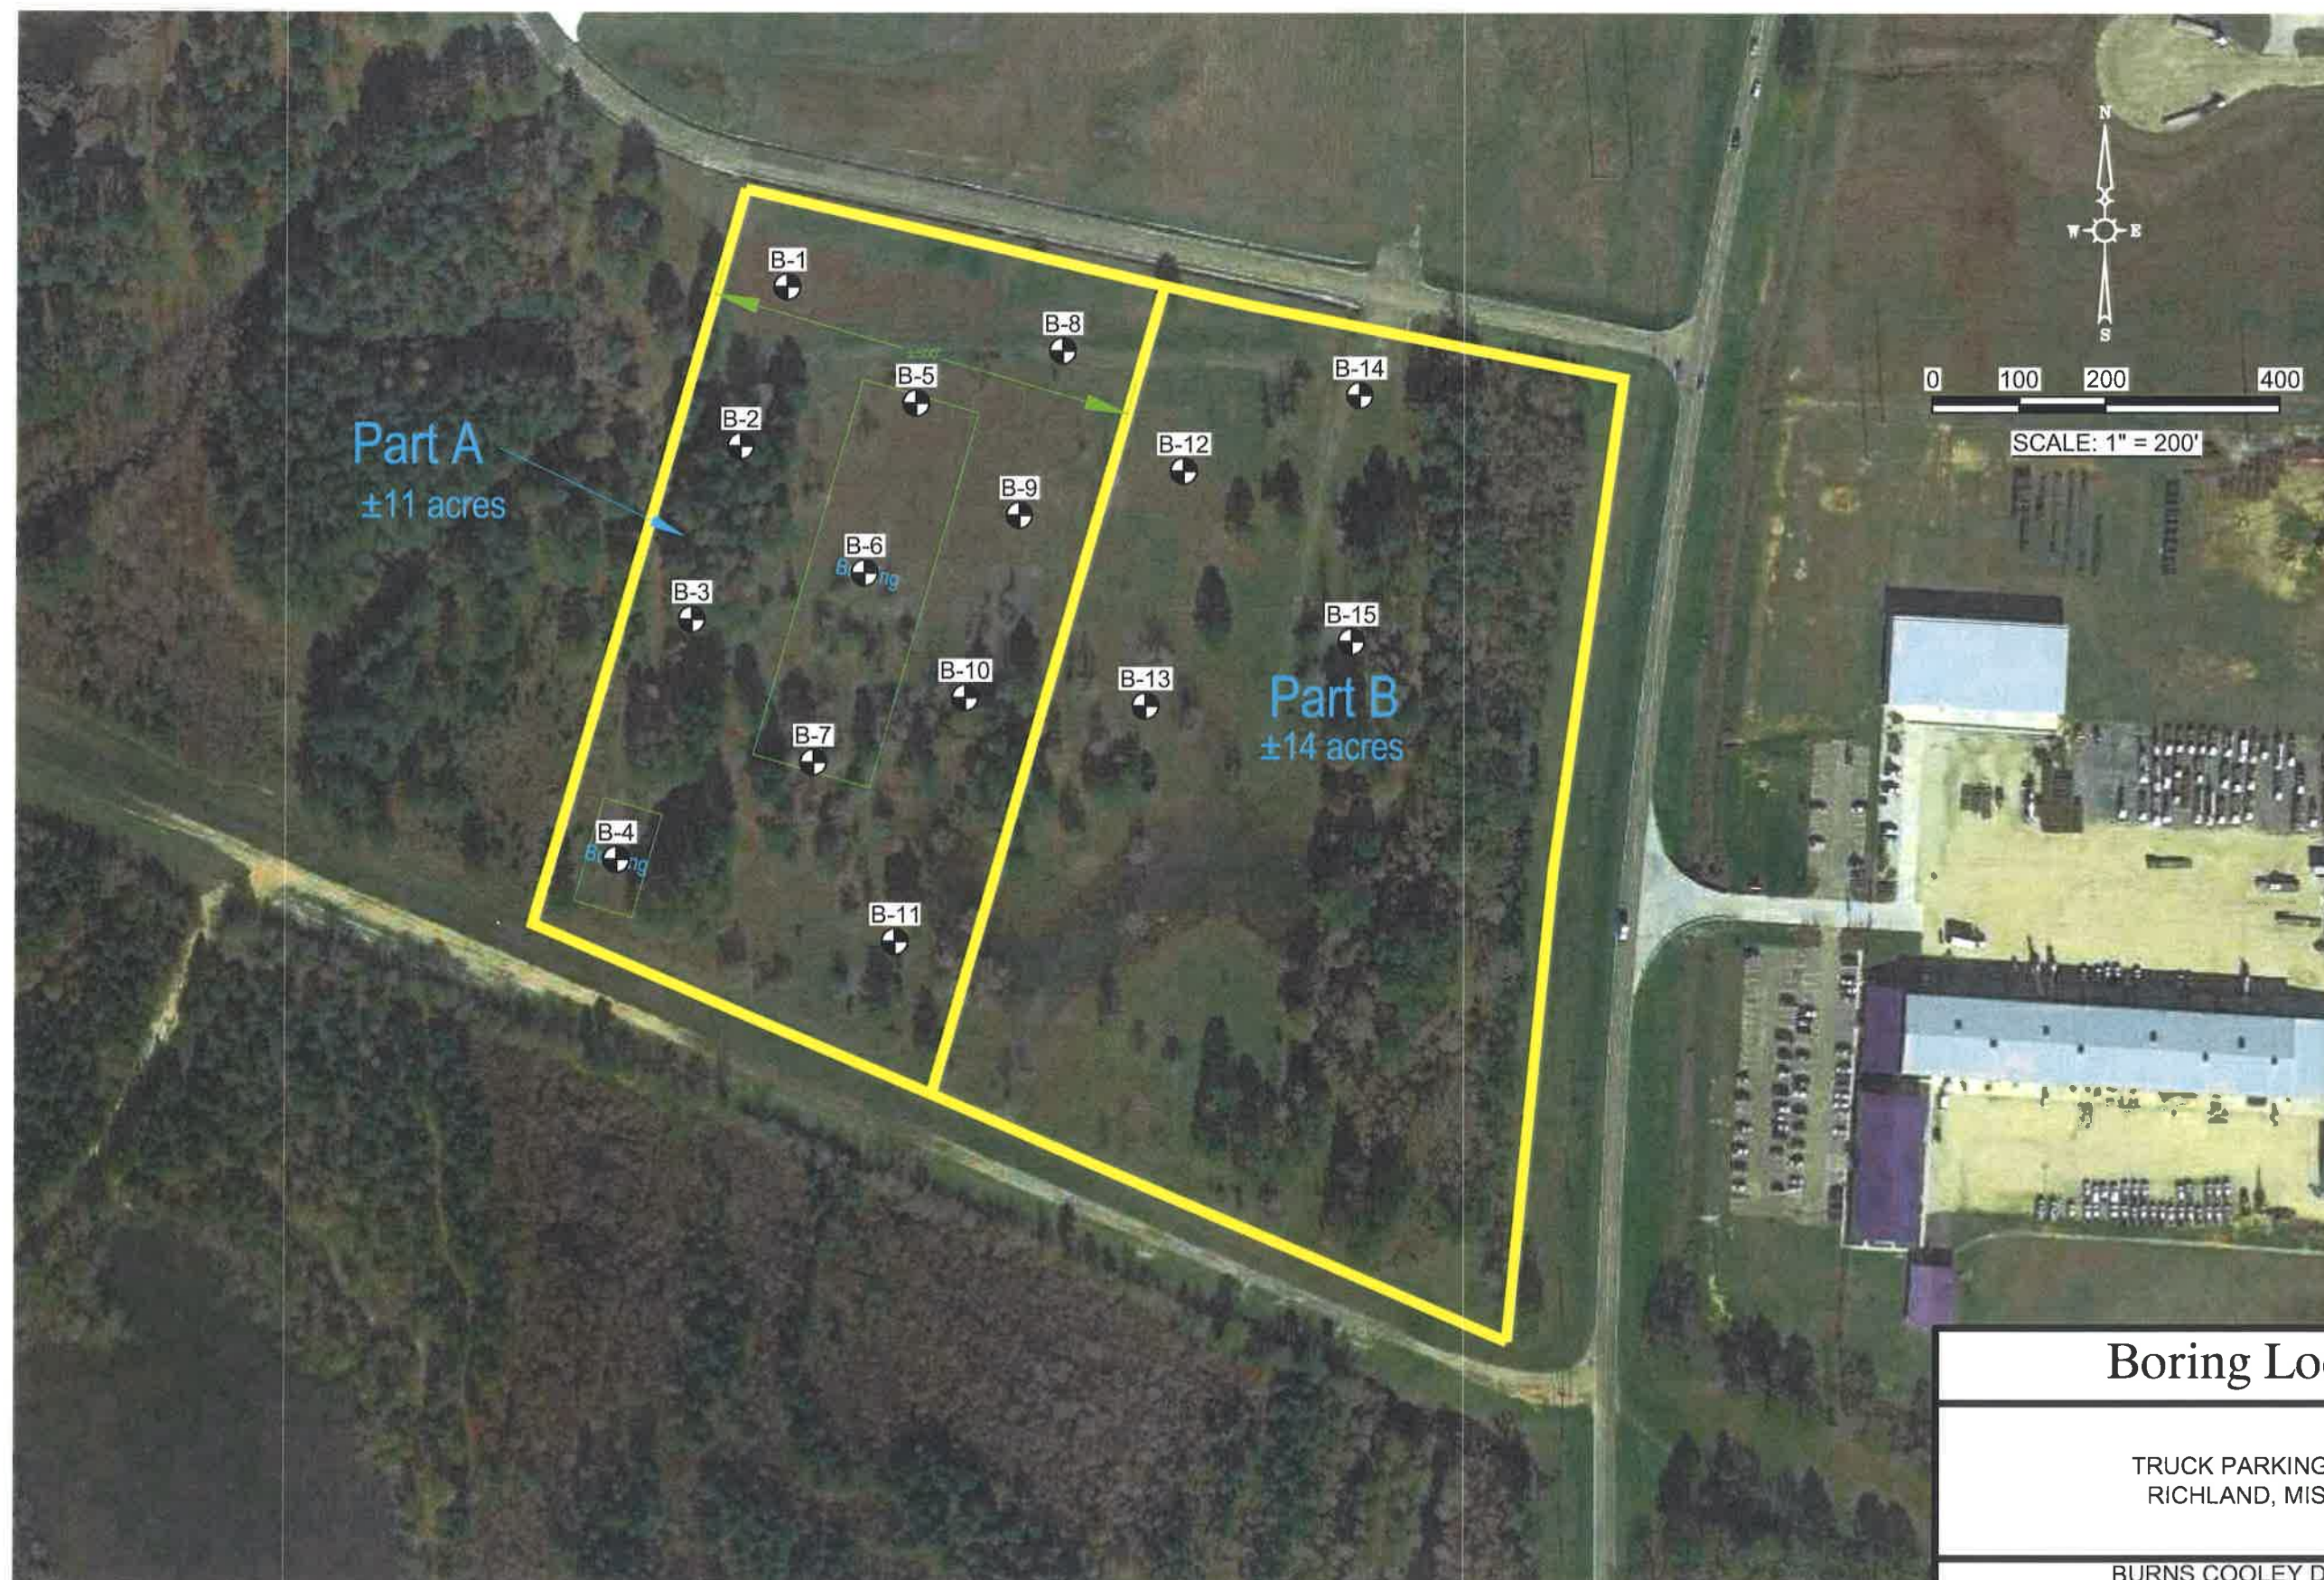
JOB NO. 170287	SCALE: AS SHOWN	FIGURE 1
----------------	-----------------	----------

## Boring Locations

TRUCK PARKING FACILITY  
RICHLAND, MISSISSIPPI

Subsurface soil conditions were explored by means of 15 borings. The boring locations and depths were determined by a Burns Cooley Dennis representative. The approximate locations of the borings are shown on Figure 1. The borings were located in the field by the use of a hand-held GPS unit with coordinates depicted from Google Earth. Approximate GPS coordinates for the boring locations are shown at the bottom of the graphical logs within the "Comments" section.
